Industry and inspiration

Art and science coincide in painstaking restoration of historic iron furnace's prized gothic-revival elements

The Cornwall Iron Furnace, in Lebanon County, PA, operated from 1742 to 1883.

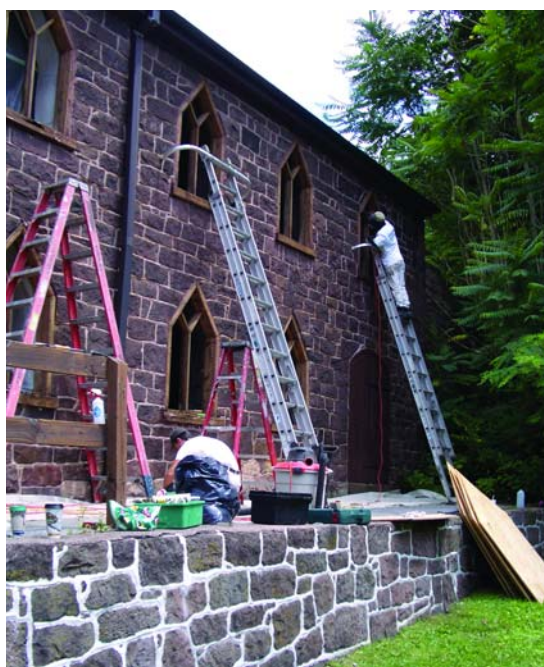
Craftsmen with Hoffman Painting & Refinishing at work during restoration of the windows at the iron furnace.
Photos courtesy of Pennsylvania Historical and Museum Commission, Craig A. Benner photographer

ened paint workable. The task, involving a set of scraping tools, is methodical and requires care. "This is all delicate antique glass," Hoffman says. Stripping of paint from interior mutins is facilitated with a heat gun. Following removal of all the old paint, the sash was evaluated for repair needs. Some new pieces were crafted in the "Dutchman" fashion to match the original longleaf-pine sash.

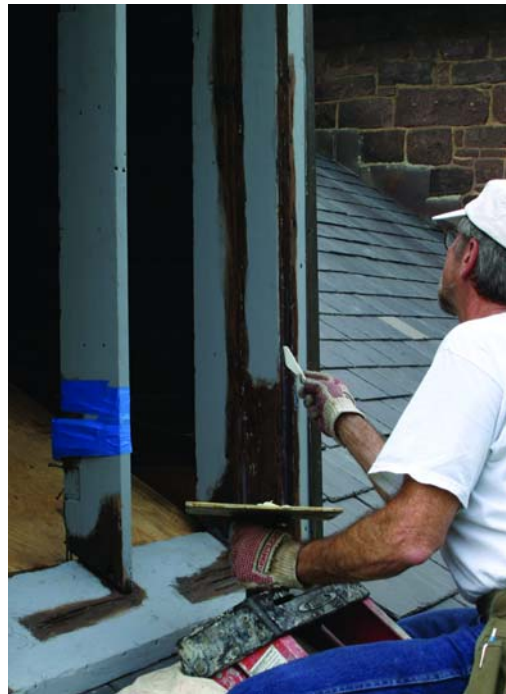
Window sash was removed, repaired, and refinished at Hoffman Painting & Refinishing's shop in Pipersville, PA. Here, Hoffman journeyman wood restorer Mike Orrell is shown at work repairing window frames and sills, which were restored in place at the Cornwall Furnace historic site.

The window frames, or jambs, and sills were restored and refinished "in situ" at the iron furnace. Stripping of old paint was accomplished using an infrared paint remover called a Steed Heater, available from Eco-Strip. The device does no harm to the wood as infrared heat pulls the paint out of the wood, allowing it to be scraped off. No chemical strippers were used.

With all the paint off, a detailed examination of all the wood surfaces assessed the need for repairs. Here, considerable checking, or cracking, of wood was evident, along with the presence of various types of bonding fillers that were used for previous repair work, but now in various stages of advanced degradation. Highly damaged wood was repaired in the Dutchman fashion, using epoxy repair material to set the new wood in place. In a handful of cases, sills were completely replaced, using Spanish cedar, an imported species highly resistant to rot. The original sills are oak, most likely white oak.

Using a die grinder, the cracks were cleaned of debris and surfaces were sanded. Also removed was all mastic caulk previously applied between the wood window frames and the adjacent sandstone window openings. The borate preservative mixture was sprayed into 3/4-inch holes drilled into the tops of the sills. The borate was then applied to all bare wood on the frames and sills.

The epoxy repair material was used as needed on the frames and sills, as was done with the sash. The epoxy-repaired surfaces were sanded, and a specially designed, metal abrader tool was employed to give the epoxy surface a hand-planed look to match the texture in the original wood. Areas repaired with epoxy were spot-primed using a gray-tinted latex paint, Muralo Ultimate Exterior Cedar Solution #2201. The water-based, acrylic primer seals the epoxy by means of a proprietary stain-blocking technology to prevent contact with oil in the linseed oil primer, which could react with the amine component in the epoxy.

The restoration and refinishing steps for the sills and frames were completed with a first coat of linseed oil primer; drying; light sanding; application of a second coat of oil-based primer; another sanding; and application of two finish coats using Muralo's Ultimate latex acrylic, medium gloss, dark brown in color.
